MM8000 MP4.15-01 Management Station

Release Notes

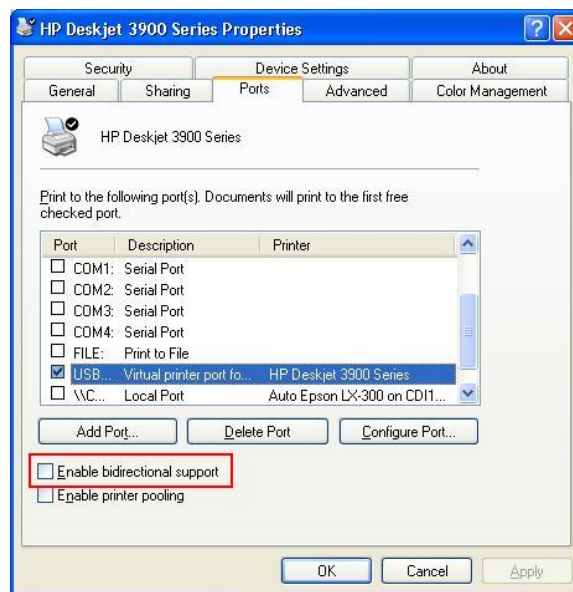
If a USB printer reports a fault condition in MM8000, try to remove the Bidirectional Control option in the printer properties page. Please follow this procedure:

1. Open the USB printer properties window (see picture below).
2. Select the "Ports" tab.
3. Uncheck the option "Enable bidirectional support".
4. Cancel all pending jobs in the spooler (most of them will be named "Check"). If you are not able to delete them, reboot the PC and make sure that the spooler list is empty.
5. Retry MM8000 printouts.
