MM8000 MP4.20-01 Management Station

Release Notes

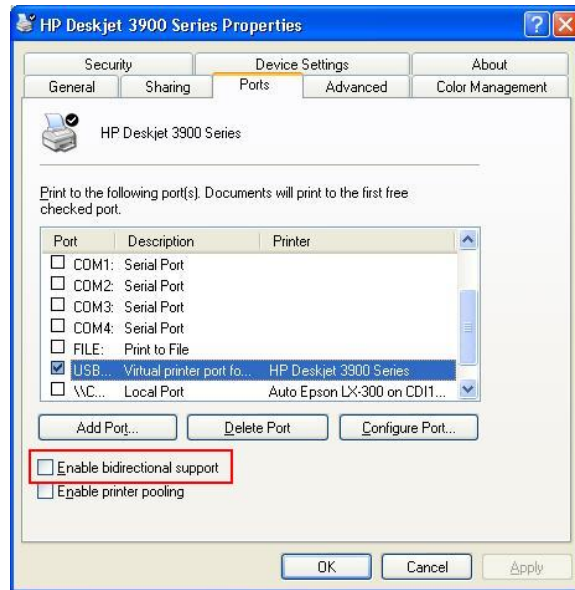
USB Printers

If a USB printer reports a fault condition in MM8000, try to remove the Bidirectional Control option in the printer properties page. Please follow this procedure:

1. Open the USB printer properties window (see picture below).
2. Select the "Ports" tab.
3. Uncheck the option "Enable bidirectional support".
4. Cancel all pending jobs in the spooler (most of them will be named "Check"). If you are not able to delete them, reboot the PC and make sure that the spooler list is empty.
5. Retry MM8000 printouts.
