MM8000 MP4.80 Management Station Release Notes

DMS8000 software **MP4.80** is now available for MM8000, MK8000, and NK8000 products.

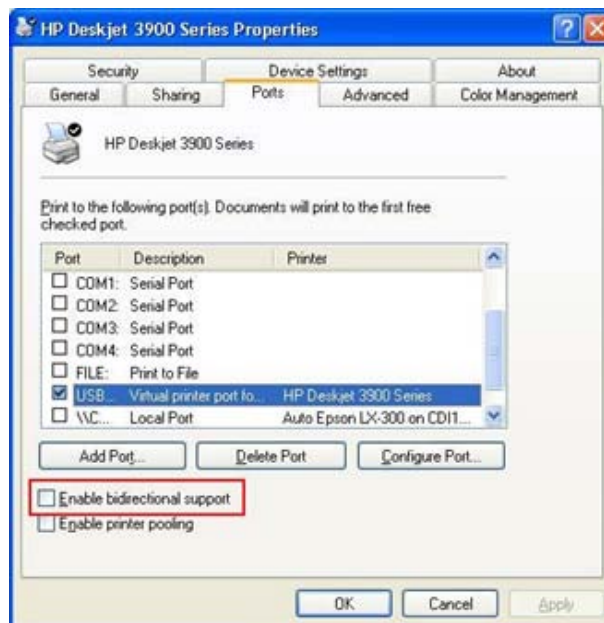
If a USB printer reports a fault condition in MM8000, try to remove the Bidirectional Control option in the printer properties page. Please follow this procedure:

1. Open the USB printer properties window (see the following picture).
2. Select the **Ports** tab.
3. Uncheck the **Enable bidirectional support** option.

4. Cancel all pending jobs in the spooler (most of them will be named **Check**). If you are not able to delete them, reboot the PC and make sure that the spooler list is empty.
5. Retry MM8000 printouts.
