TechTopics No. 121

Ground return currents in gas-insulated switchgear

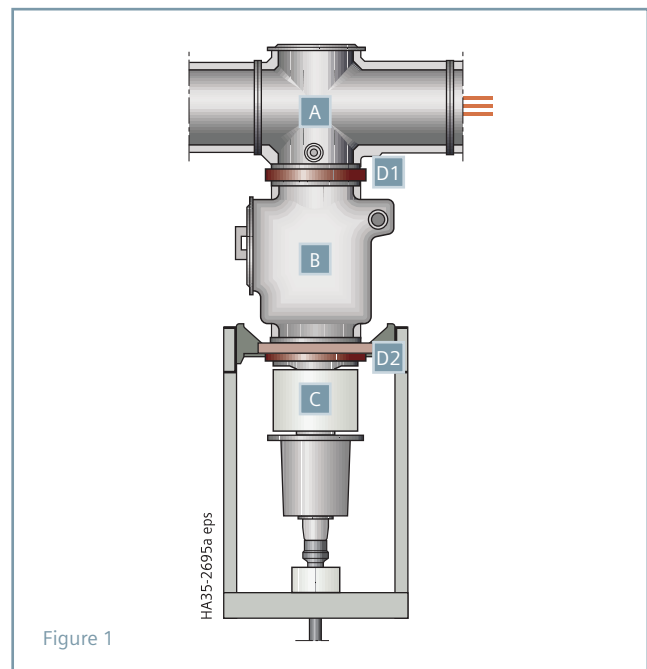
The graphic in Figure 1 illustrates a typical circuit breaker unit of single-bus type 8DA gas-insulated switchgear. The main bus housing (A) is located at the top, with the vacuum interrupter housing (B) located below, and the current transformer housing (C) located beneath (B).

Item	Description
A	Main bus housing
B	Vacuum interrupter housing
C	Current transformer housing
D1	Insulator and gas barrier
D2	Insulator
E	Ground jumpers between main bus housings (A) and interrupter housings (B)
F	Ground connection
G	Main bus housing ground jumpers

The red areas between compartments indicate the epoxy insulators that electrically separate the compartments from each other.

Some of these are open to allow gas transfer between compartments (D2) and some of these (D1) are gas barriers for the isolation of the switchgear into appropriate gas zones.

Returning to Figure 1, the epoxy insulator D2 does not have a ground jumper directly between the vacuum interrupter housing (B) and the CT housing (C). Thus, there is no current connection for ground return current through the aluminum housings. Instead, the connection is made from the bottom of the CT housing directly to the ground bus of the switchgear, allowing ground current to return to ground, but not allowing the ground return current to pass through the current transformer window.

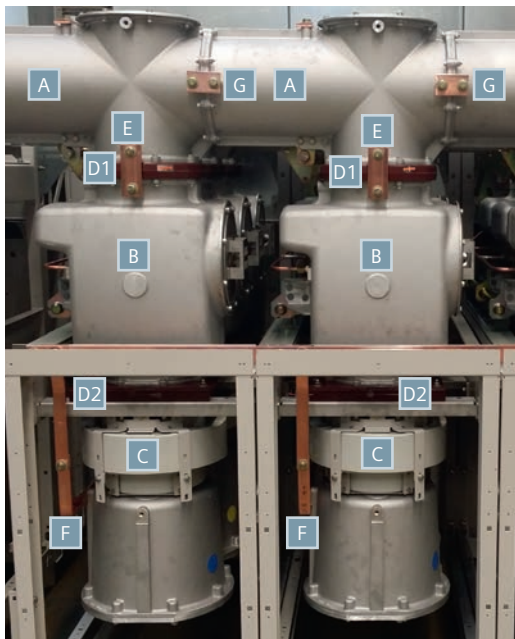
The switchgear includes ground jumpers to connect the various housings together and to the switchgear ground bus. The photo in Figure 2 shows examples of ground jumpers (G) between adjacent housings in the bus bar area (A), and ground jumpers (E) between the bus bar housing and interrupter housings (B). However, the manner of grounding in the area of the CTs differs.

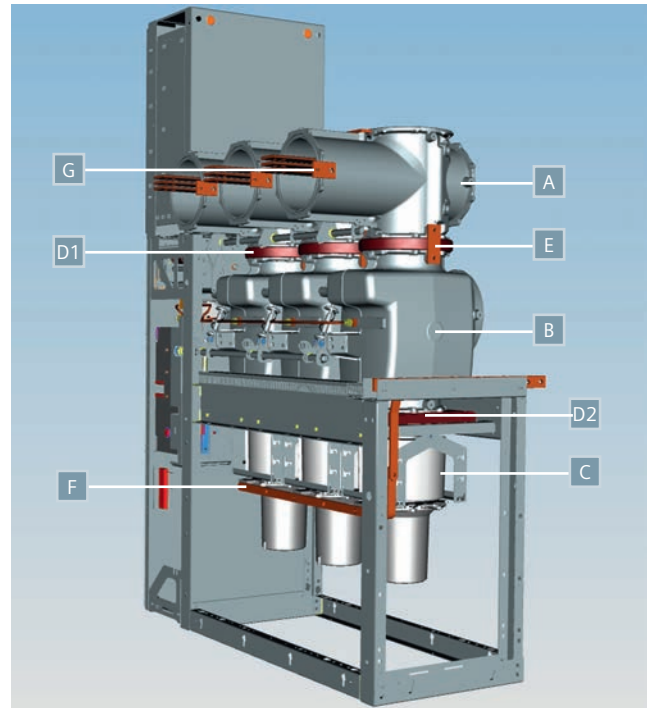
Figure 3

This is illustrated in Figure 3. This shows the connection from the bottom side of the CT housing to the ground bus system of the switchgear.

The CTs are mounted in area C. The epoxy bushing between the CT housing (C) and the vacuum interrupter housing (B) does not have a grounding jumper across the epoxy bushing.

Instead, the ground connection (F) is made to the bottom of the CT housing, preventing the ground return current from passing directly through the CT window.
