MM8000 MP4.20-01 Management Station

Release Notes

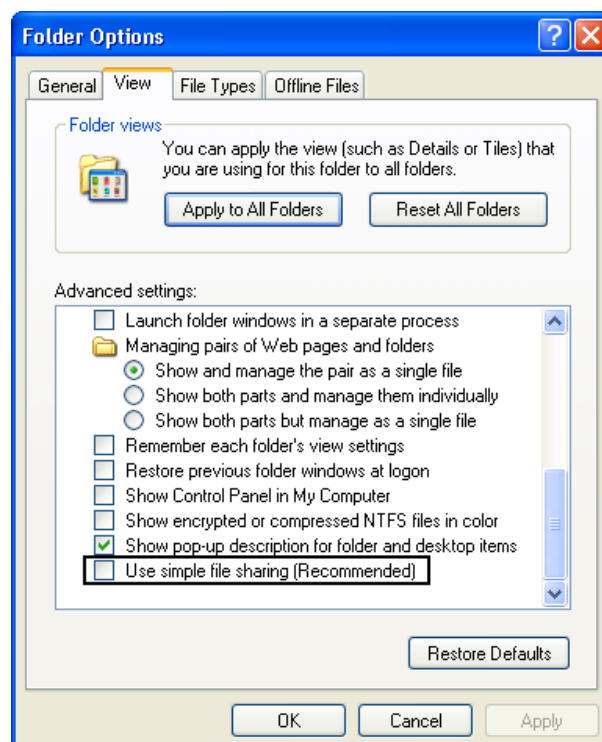
– In case of communication problems between MM8000 and SiPass, make sure not to check the Windows Explorer folder option: **Use Simple File Sharing** (select **Tools**→**Folder Options** in the Explorer menu and then click the **View** tab as illustrated here below). The option should NOT be enabled on the SiPass server PC.
