MM8000 MP2.31

Management Station

Product Release Notes

Fire & Security Products

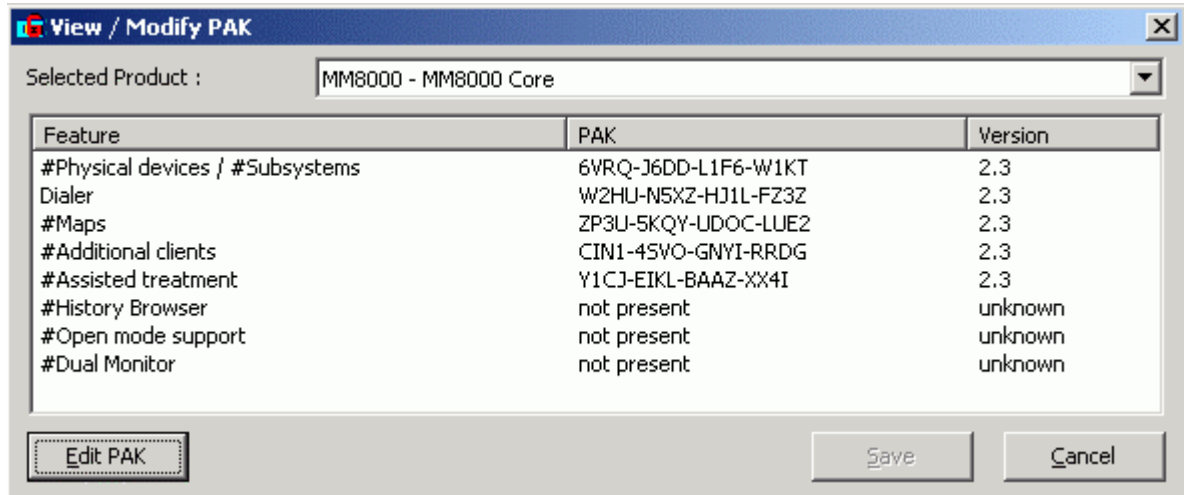
On an existing MP2.30, there might be an incomplete set of codes that is detected by MP2.31, whereas MP2.30 could tolerate it. This is likely to occur on earlier MP2.3 licenses release: **carefully check your license codes before updating to MP2.31.**

This verification should concern the “MM8000 core” license; as an example, please see the following case:

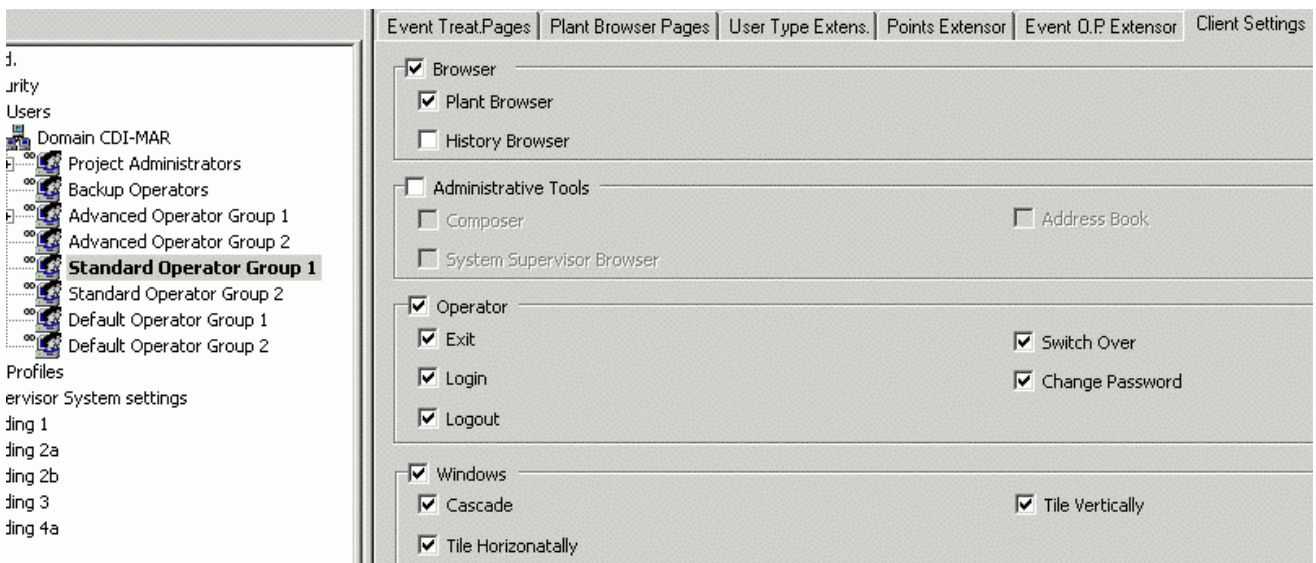
1. Before starting any activity, check the installation requirements and the necessary license for MP2.31.
 - See document 006799 “MM8000 Installation Configuration & Commissioning guide”.
2. In the MP2.10/MP2.20 configuration, take note of the “Client settings” of each of the User Groups (see figure and form below).

Level	System Name	Plant browser	History browser	Composer	System Sup.	Address Book	MM8000 Exit	Operator login	Operator logout	Operator switchover	Change password	Windows (cascade)	Preferred view	Station mode	Windows Applications
4	Project Administrators														
3	Backup Operators														
2.	Advanced Operator Group 1														
2.	Advanced Operator Group 2														
1.	Standard Operator Group 1														
1.	Standard Operator Group 2														
0.	Default Operator Group 1														
0.	Default Operator Group 2

15. After that, using the form prepared at step 0 above, check and possibly correct the “Client settings” associated to each user group.
16. If the projects include graphic maps, you will need to update their format. Select the node “Graphic maps” and click ‘Update’
17. The update procedure will proceed for some minutes, depending on the size of the project. Wait for the procedure to complete.
18. Close Composer.
19. Reset the Composer “Debug mode” launching the utility:
C:\MM8000\Utilities\Reg\ST_DebugNo.reg

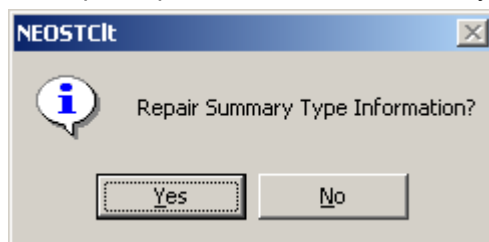
4. Restart the computer.
5. Verify that the <target directory> folder (by default C:\MM8000) has been deleted as well. If not, manually delete it.
6. Follow the installation instructions detailed in the document 006799 “MM8000 Installation Configuration & Commissioning guide”.
7. If required, install the translated texts as described in 007875 “MM8000 Localisation Guide”. If you need to migrate MP2.30 texts, see 3.3.1 at p.16.
8. Set Composer tools in “Debug mode”: Launch the utility.
C:\MM8000\Utilities\Reg\ST_DebugYes.reg
9. Start Composer and restore your project.
10. In the MM8000 structure tree, select
Supervision ... → MM8000 System → Logical Configuration → User Data
11. On the Node tab, press the button labelled “Project Update”.
12. The update procedure will start and may present a window like the following:

We recommend you to select 'Yes'.

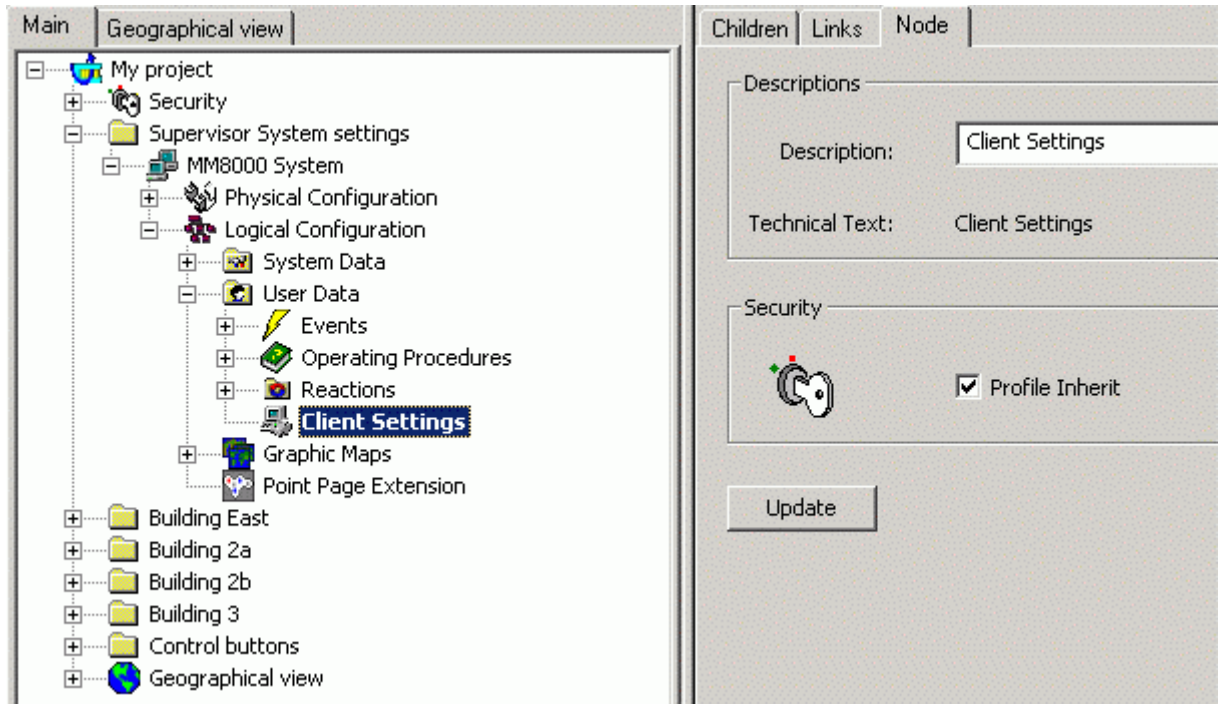
13. The update procedure will proceed for some minutes, depending on the size of the project. Wait for the procedure to complete.
14. The MP2.10 or MP2.20 projects need now the “Client Settings” update. Select the node:
User Data → Client settings
and click 'Update'. The update procedure will quickly execute.

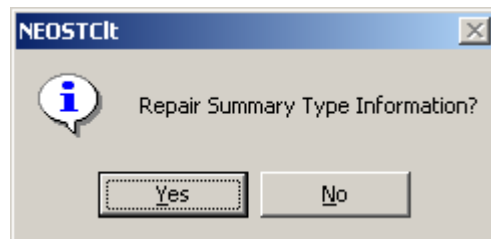
10. On the Node tab, press the button labelled “Project Update”.
11. The update procedure will start and may present a window like the following:

We recommend you to select 'Yes'.
