## AlgoRex EP7F-Z2.1

### Release Notes for Tool Coordinators

**Building Technologies**

Fire Safety & Security Products

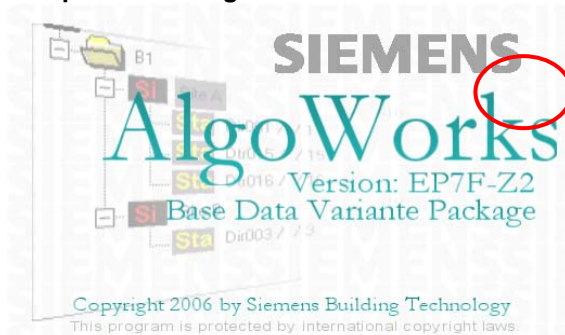
**Setup with missing files**

Please see the following pictures to find out which setup you carried out.

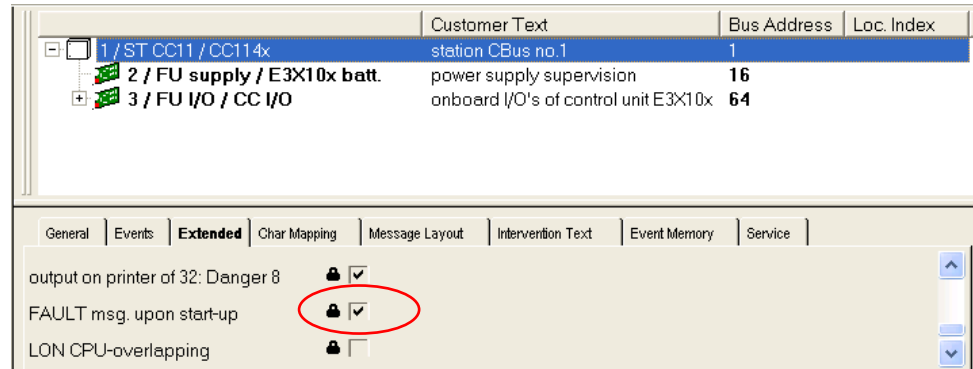
This Boolean has been set to TRUE because of the maintenance information FD\_06\_003\_MI\_en.

The country defaults for Stations CC11, CI11 and CT11 are affected. CK11 does not support this configuration field.

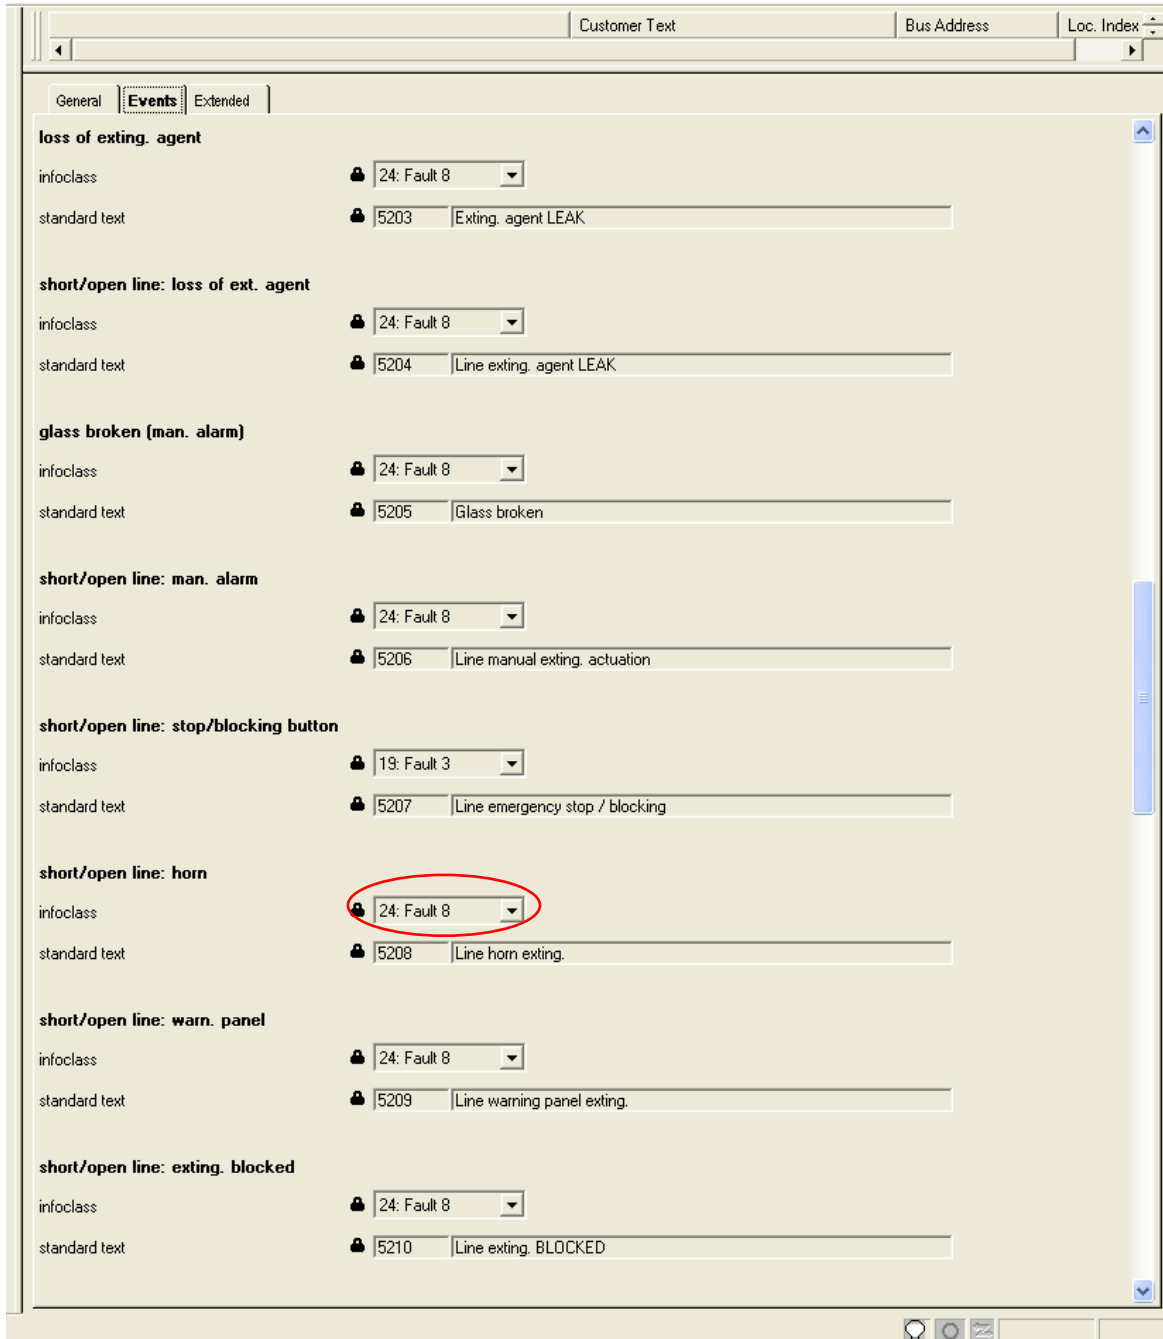
### Tab “Events”

- set all fault-infopoints to **Fault8** (resetable) EXCEPT infopoint “stop/blocking button” which must be **Fault3**
- set “exting. blocked” infopoint to **Information6** (not shown)
- set “autom. + man. Exting. Blocked” to **Information2** (not shown)

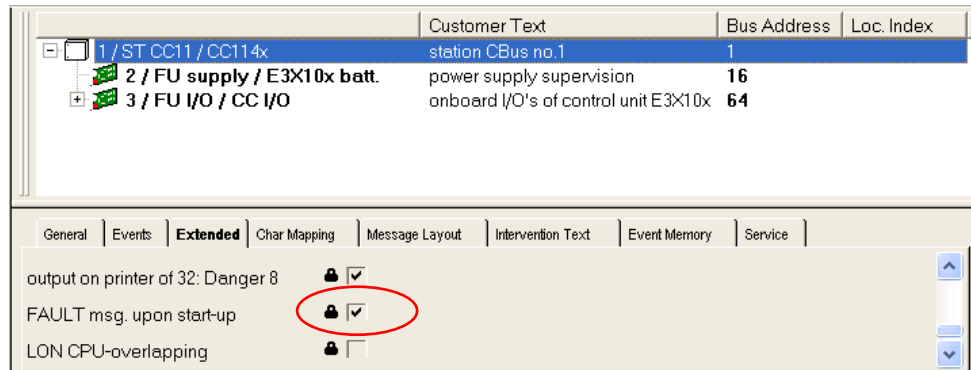
This Boolean has been set to TRUE because of the maintenance information FD\_06\_003\_MI\_en.

The station templates for station CC11, CI11 and CT11 are affected. CK11 does not support this configuration field.

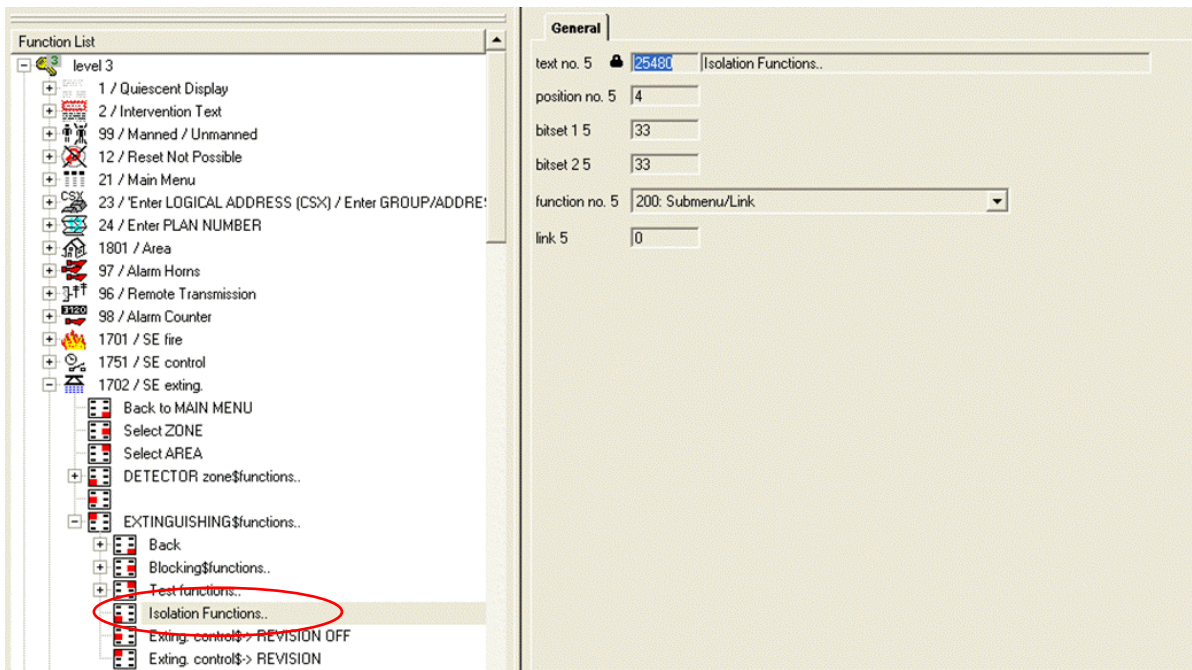
### 7.7.4 Remove obsolete function list entry

The station templates for station CI11 and CT11 are affected.

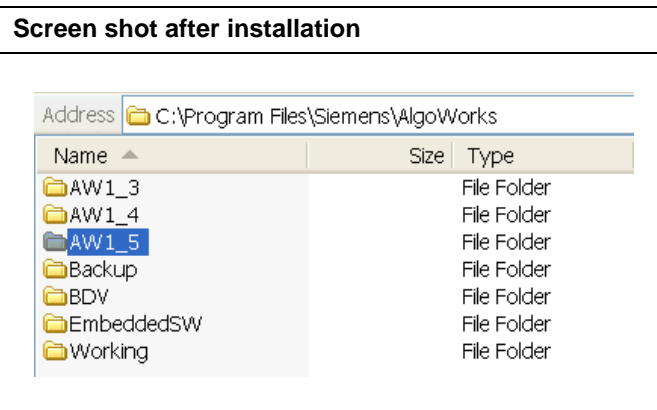
After installation, a new folder *AW1\_5* was created.

Old structure	New structure
<p>Address
