MM8000 MP4.40 Management Station

Release Notes

Fire Safety & Security Products

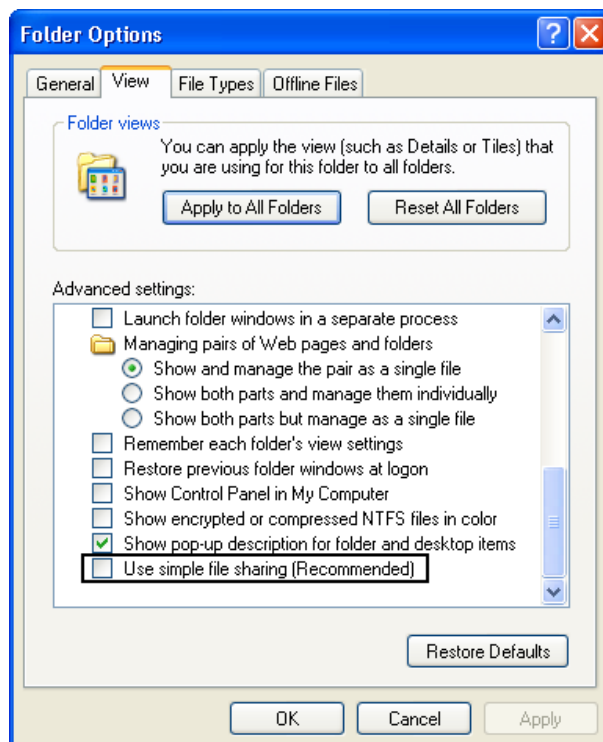
- In SiPass 2.40 and later, note that the **SiPassUser** password, required for MM8000 communication, must be in uppercase: **SIPASSPASSWORD**.
- In case of communication problems between MM8000 and SiPass, make sure not to check the Windows Explorer folder option: **Use Simple File Sharing** (select **Tools**→ **Folder Options** in the Explorer menu and then click the **View** tab as illustrated below). The option should NOT be enabled on the SiPass server PC.

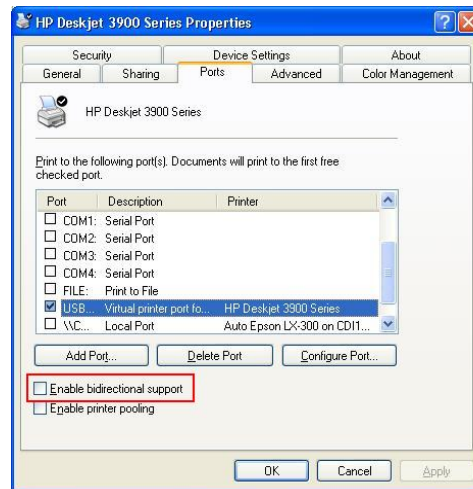
1. Open the USB printer properties window (see the following picture).

2. Select the **Ports** tab.
3. Uncheck the **Enable bidirectional support** option.
4. Cancel all pending jobs in the spooler (most of them will be named **Check**).
If you are not able to delete them, reboot the PC and make sure that the spooler list is empty.
5. Retry MM8000 printouts.
